**Condition Based Maintenance
for Legacy Aircraft**

**Presentation to ISHM Conference
11 August 2005
Allison M. Toms, Aiden Donahue**

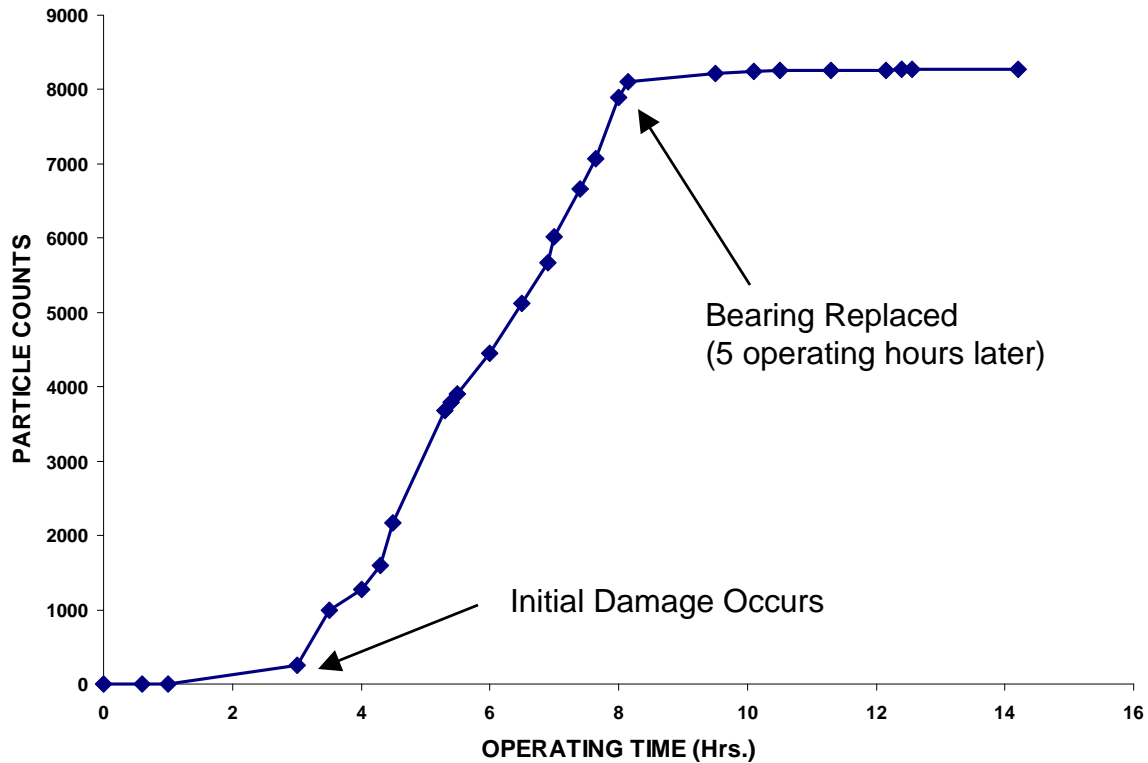
Bearing Damage - Field Data

- New engine run on test stand
- Damage due to mis-assembly
- Bearing highly overstressed
- *NO SECONDARY DAMAGE occurred*

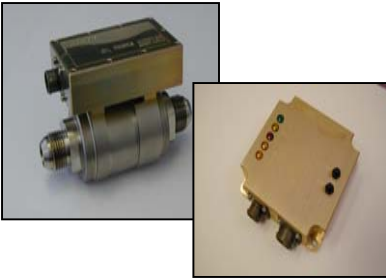
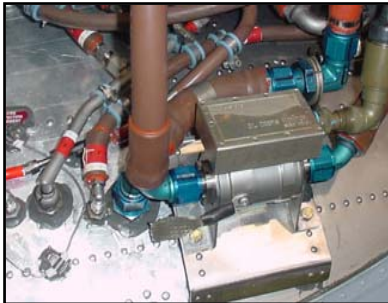
Engine Oil Debris Monitoring

- Laboratory spectrometric oil analysis program on-shore
 - In mid 90's engine failure occurred while deployed at sea
 - Oil samples “stored” until return to port
 - > Engine problem evident in stored samples
- Deployment of oil lab at sea recommended by Flight Safety
 - Shrinking staffing and expertise prohibited
- Solution: Install on-line, real time oil debris monitoring on engines

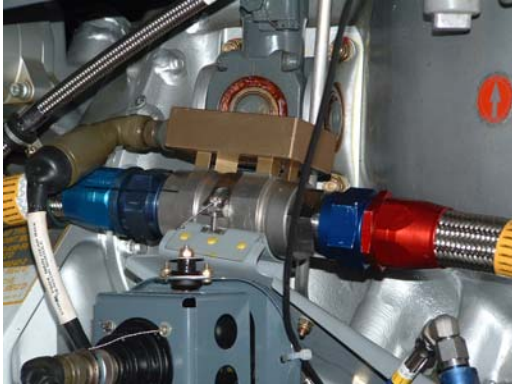
Main Gearbox - Solutions

- Test stand problems corrected
- New balance and alignment processes implemented
- New statistical vibration limits utilized
- ODM system installed on test stand
 - Successful in monitoring wear generation for early detection of assembly errors
 - Also ensured test stand runs were long enough to remove all break-in debris
- Eliminated false chip lights
- ODM currently being fitted to operational fleet for on-line monitoring

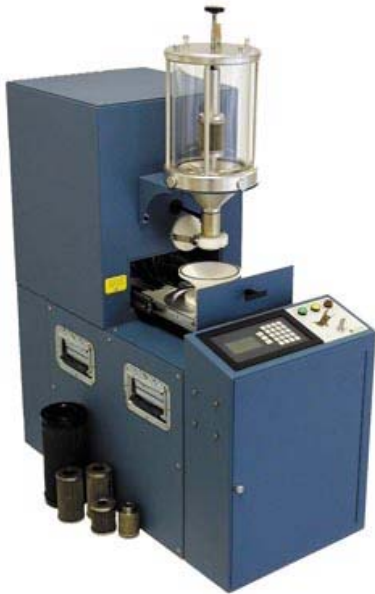
Main Gearbox – Upgrade to 24000 Series Gearbox

- Upgrade started in 1999
- 10 micron filtration (previous model had been 46 microns)
 - Wear debris trapped in filter
- Developed automated Filter Debris Analysis program for O level maintenance support
- Automated system cleans and analyzes debris in 15 minutes (implemented 2000)
 - Upgrade in 2005 to incorporate metallurgical analysis by EDXRF
- Units deployed with Sea King around the world

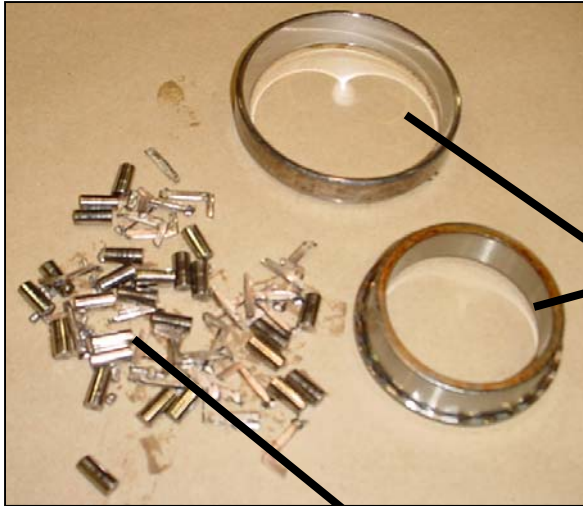
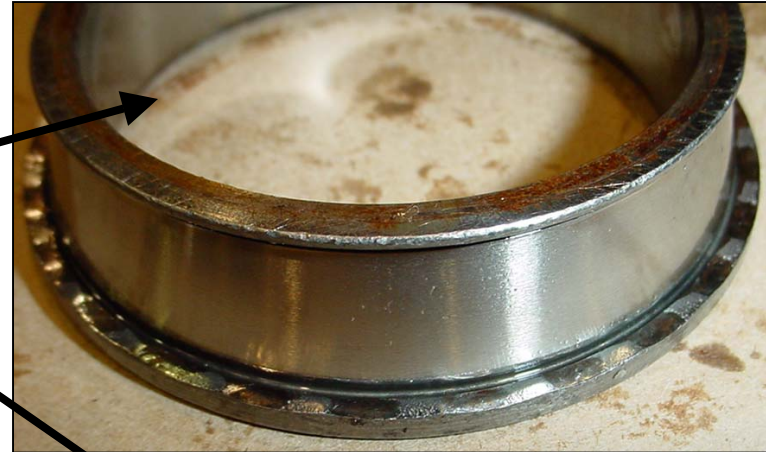
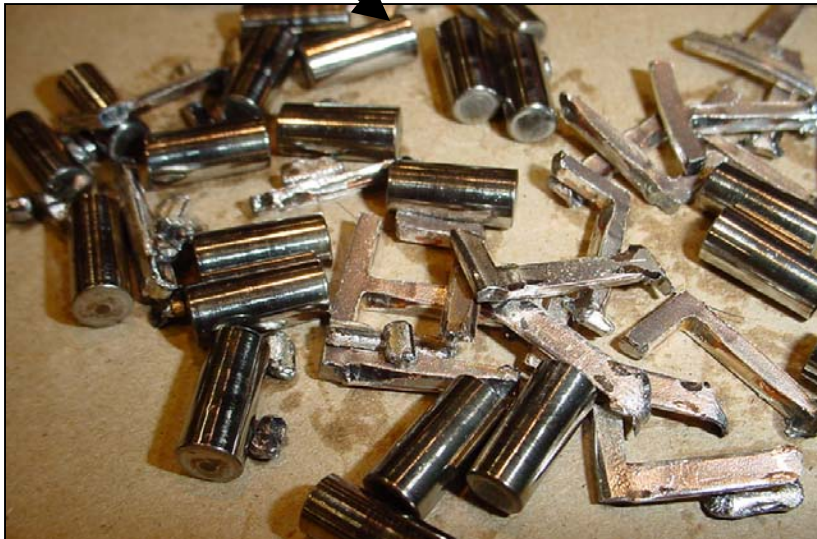
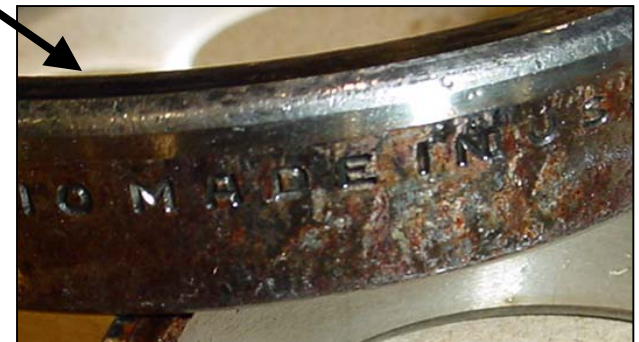
DAMAGED L/H FREEWHEEL BEARINGS

- 3 chip detectors incidents in 20 flight hours
- Filters removed and processed with ship-board Filter Debris Analyzer - heavy debris - problem severe
- Oil sample and debris sent to IHM lab
 - Debris excessive - carbon steel
 - > Not traditionally associated with wear of critical components in MGB
- At R&O facility
 - Freewheel helical gear bearings severely worn
 - > One bearing completely disintegrated
 - > Cage - carbon steel with bonding coat of Ni and outer layer of Ag
 - > Ag not found in analysis - it was deposited by centrifugal force onto inside of spur gear housing
 - Ag had de-bonded from carbon steel base metal
 - > Ni was bond layer to adhere Ag to steel

- Why was bearing failure not identified properly by IHM program?
- Reason
 - Original Sikorsky 21000 series transmission free wheel unit utilized cages composed of brass or bronze alloy
 - Sikorsky 24000 series had different metallurgy - carbon steel
- GasTOPS tasked to develop methods to identify this problem early and monitor for safe operation
 - Until OEM could design and implement repair
 - > ~2 to 3 years to upgrade fleet
- Solution: Presence of Ag or Ni - investigate
 - FDA units upgraded to include XRF on-site analysis
 - Vibration was not definitive due to random noise
